Submitted by:
AECOM
Fort Collins, CO
60634996
January 17, 2024

Basin Electric Power Cooperative Leland Olds Station

Coal Combustion Residual Landfill Annual Inspection Report –2023

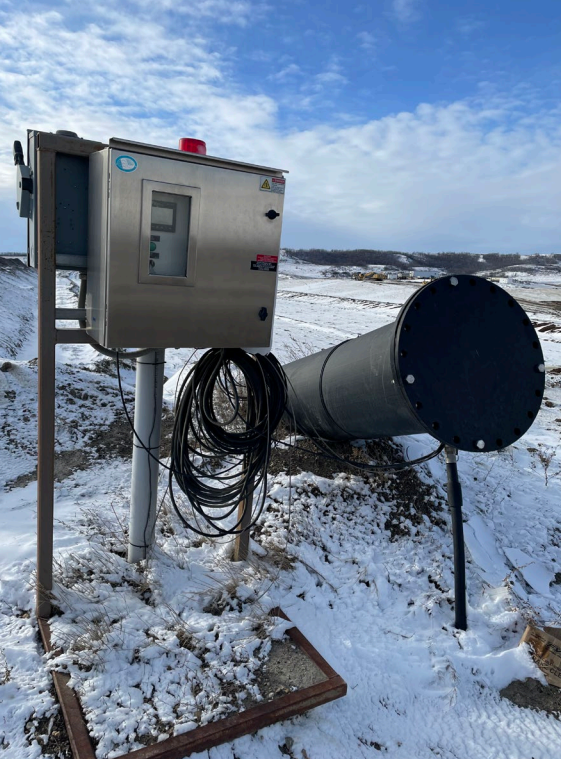
Direction Photo Taken: Southwest			
Description: <u>Location:</u> See Figure Landfill leachate collection system

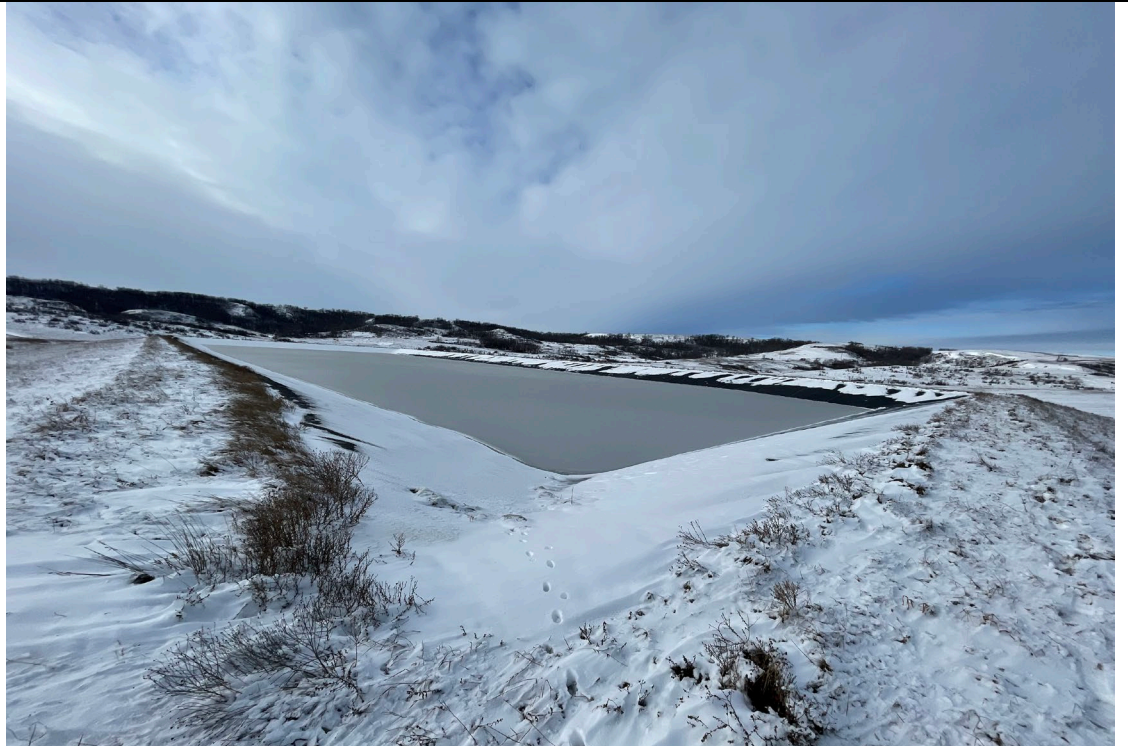
Landfill leachate collection pond

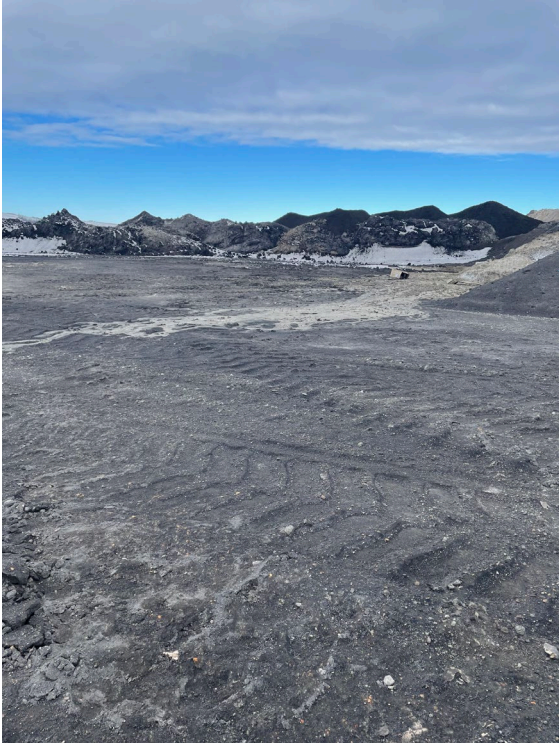
Direction Photo Taken: North			
Description: <u>Location:</u> See Figure Active working face of landfill
