Submitted to:
Basin Electric Power Cooperative
Laramie River Station
Wheatland, WY

Basin Electric Power Cooperative Laramie River Station

Coal Combustion Residual Surface Impoundment Annual Inspection Report – 2023

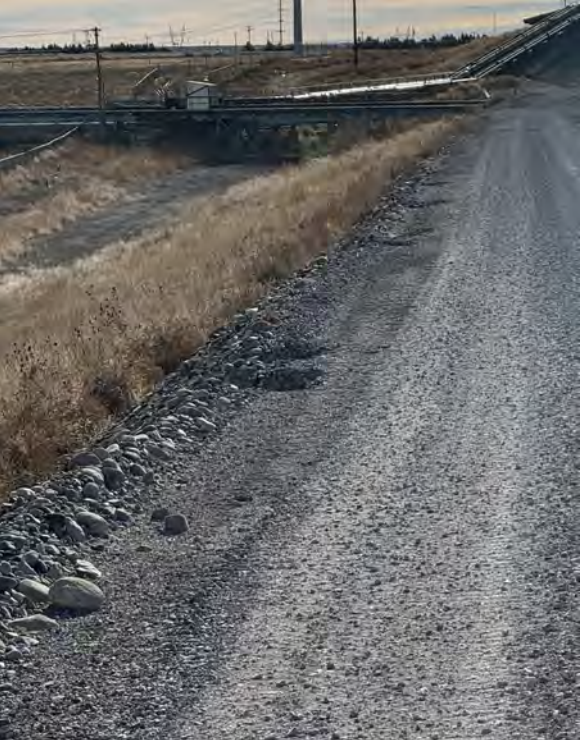
Client Name: Basin Electric Power Cooperative		Site Location: Laramie River Station, Wheatland, WY	Project No. 60632474
Photo No. 3	Date: 12/6/23

Direction Photo Taken: Southeast			
Description: <u>Location:</u> Eastern road of BAP-1 Small erosional rills are forming along the eastern road of BAP-1, outside of the liner area.

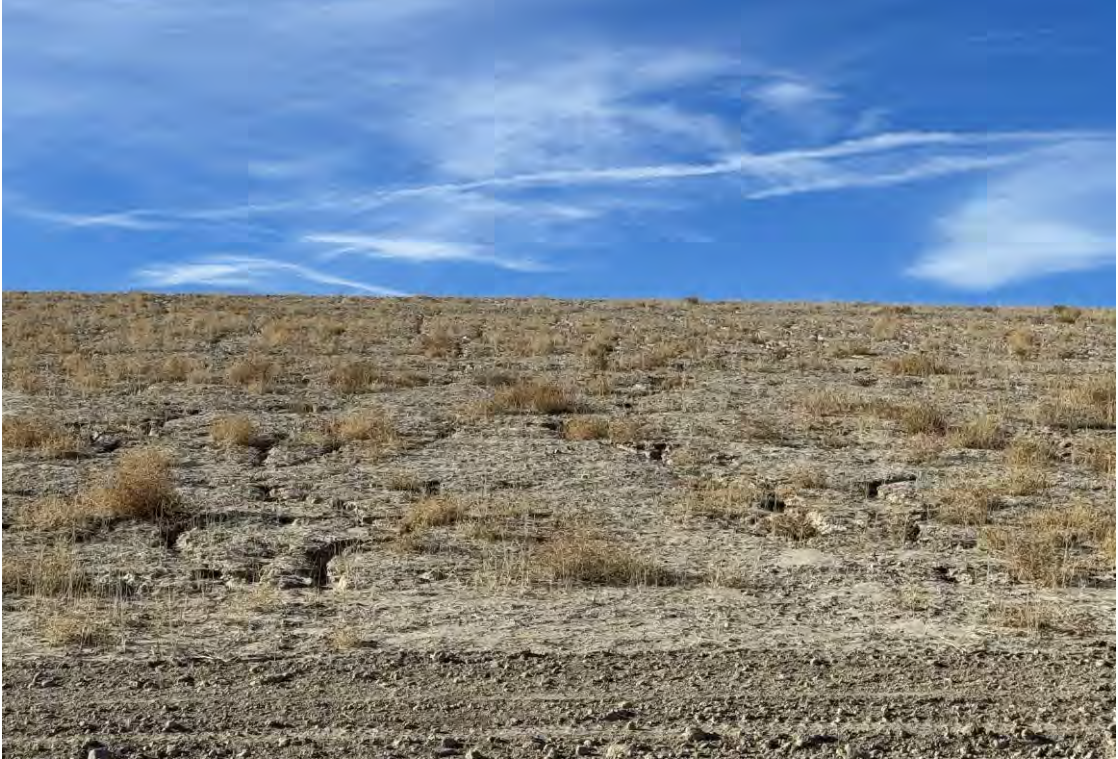
Client Name: Basin Electric Power Cooperative		Site Location: Laramie River Station, Wheatland, WY	Project No. 60632474
Photo No. 6	Date: 12/6/23

Direction Photo Taken: West			
Description: <u>Location:</u> Capped side of BAP-3 Desiccation cracking is shown. Repairs are scheduled for early 2024; some work has begun as seen at the bottom of the picture.
