Submitted to:
Basin Electric Power Cooperative
Laramie River Station
Wheatland, WY

Submitted by:
AECOM
Fort Collins, CO
60632474
January 17, 2024

Basin Electric Power Cooperative Laramie River Station

Coal Combustion Residual Landfill Annual Inspection Report – 2023

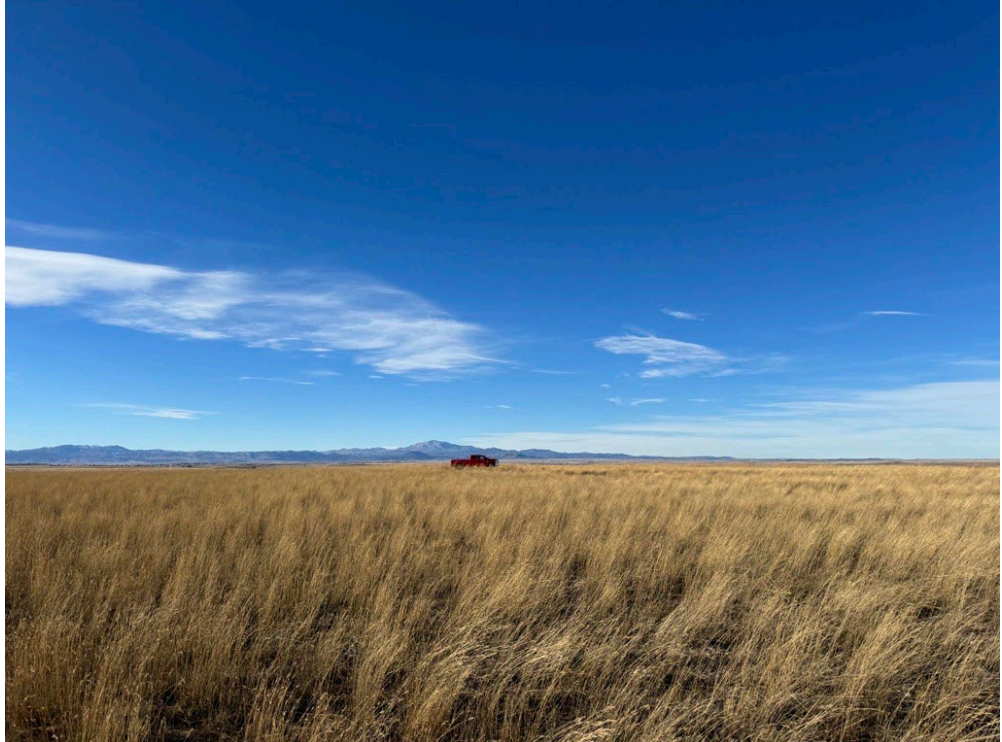
Client Name: Basin Electric Power Cooperative		Site Location: Laramie River Station, Wheatland, WY	Project No. 60632474
Photo No. 2	Date: 12/6/23

Direction Photo Taken: West			
Description: <u>Location:</u> Top of the capped landfill Good vegetation cover is shown.
