2024 Annual Landfill Inspection

Antelope Valley Station Coal Combustion Residual Landfill

Prepared for
Basin Electric Power Cooperative

Prepared by
Barr Engineering Co.

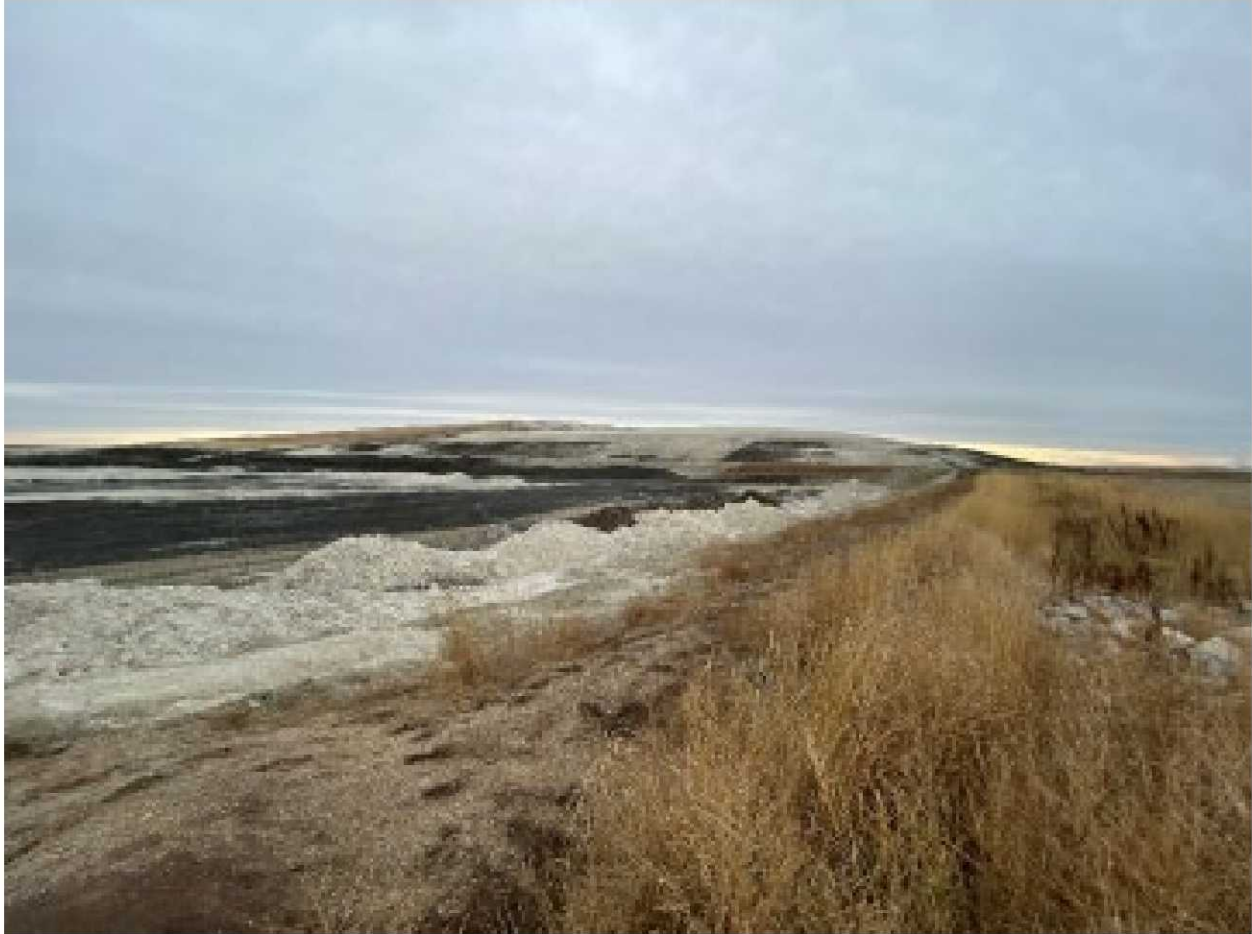
Subject: North-northwest corner of active area, view to southeast

Comments: Bottom liner of expansion area has been protected by layer of CCRs; fill progression appears consistent with plan.

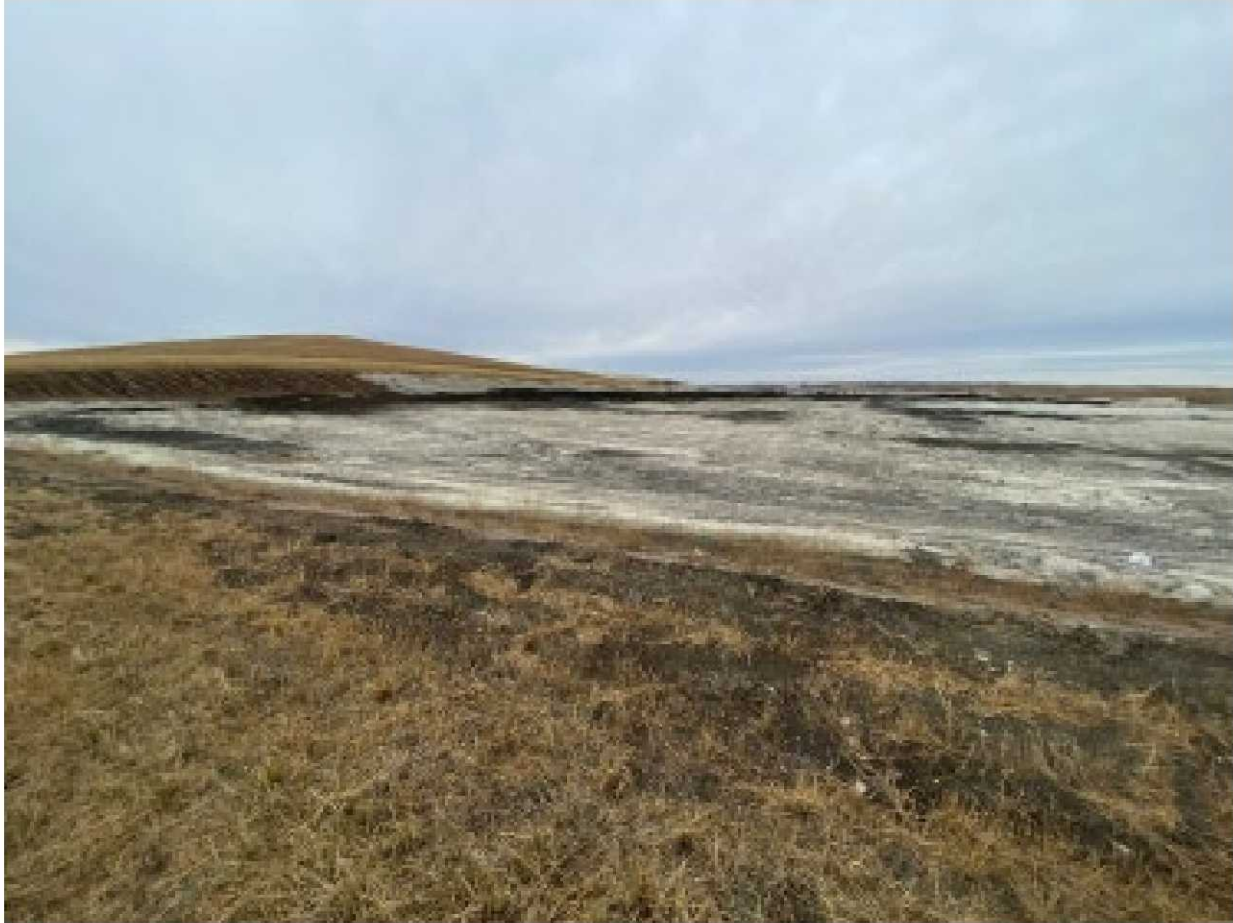
Subject: North-northeast active area, view to southwest

Comments: East perimeter berm vegetation still growing in

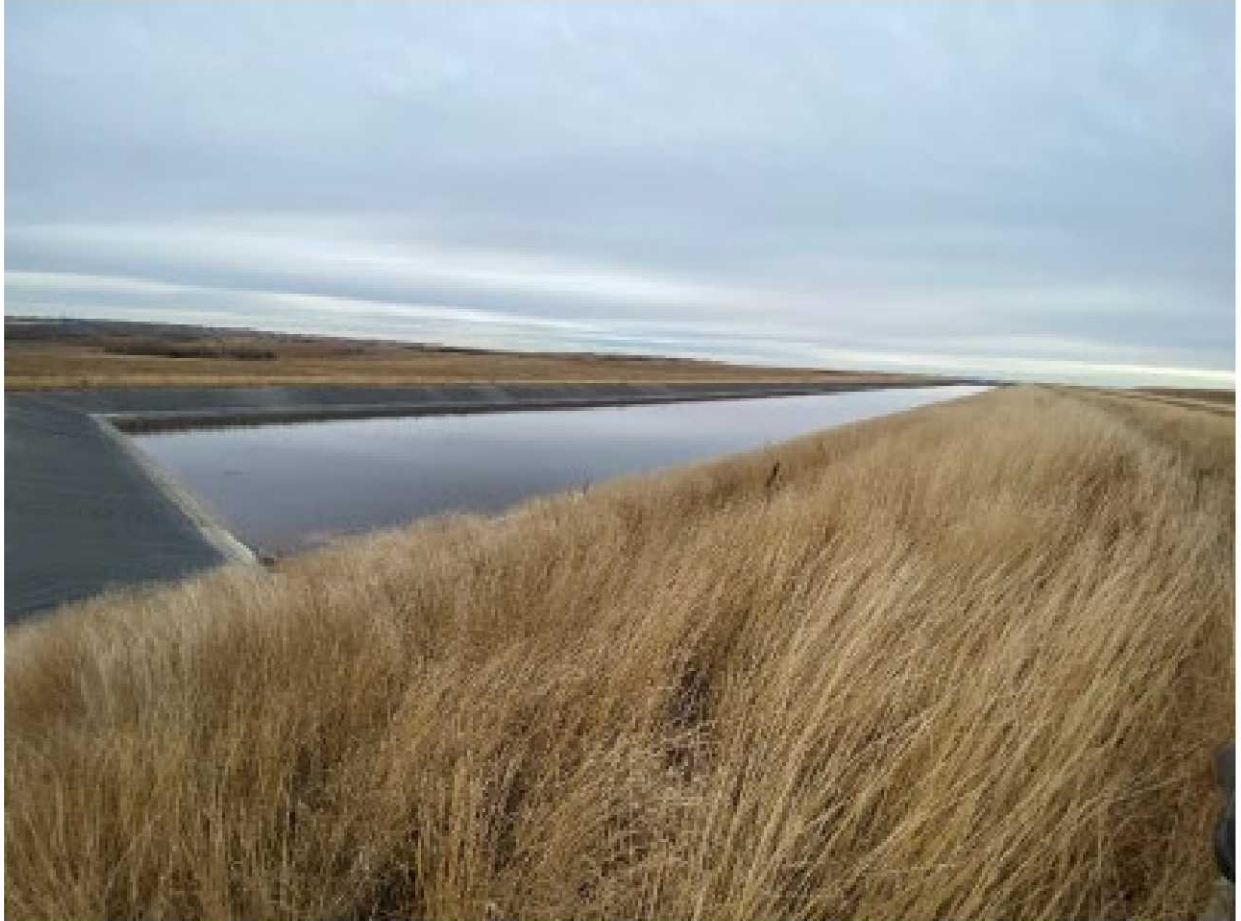
Subject: Southeast corner of leachate pond, view to northwest

Comments: Pond has adequate freeboard.

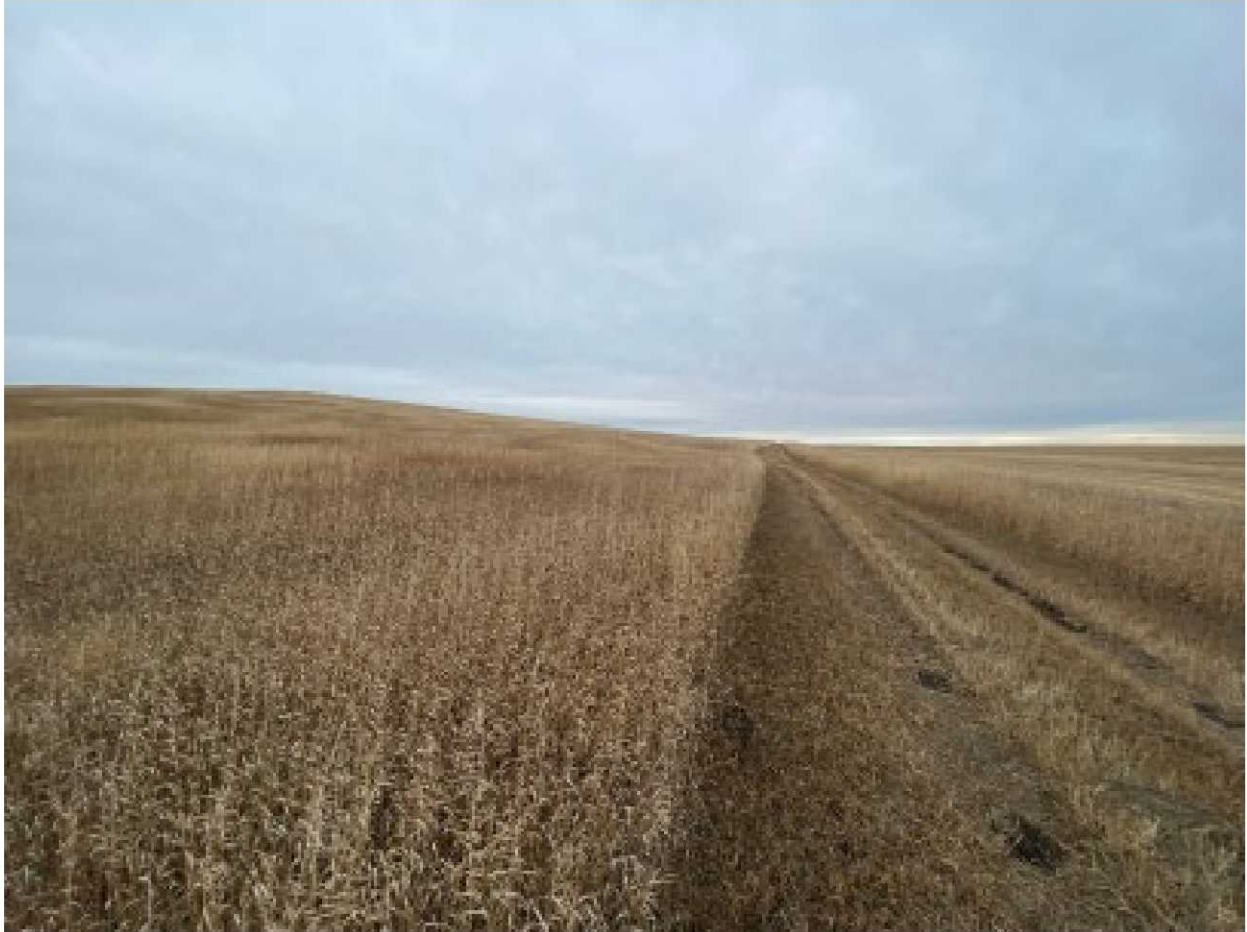
Subject: Southeast corner of closed area, view to north along east perimeter

Comments: Excellent vegetation on closed areas, no evidence of erosion.
