2024 Annual Landfill Inspection

Leland Olds Station Coal Combustion Residual Landfill

Prepared for
Basin Electric Power Cooperative

Prepared by
Barr Engineering Co.

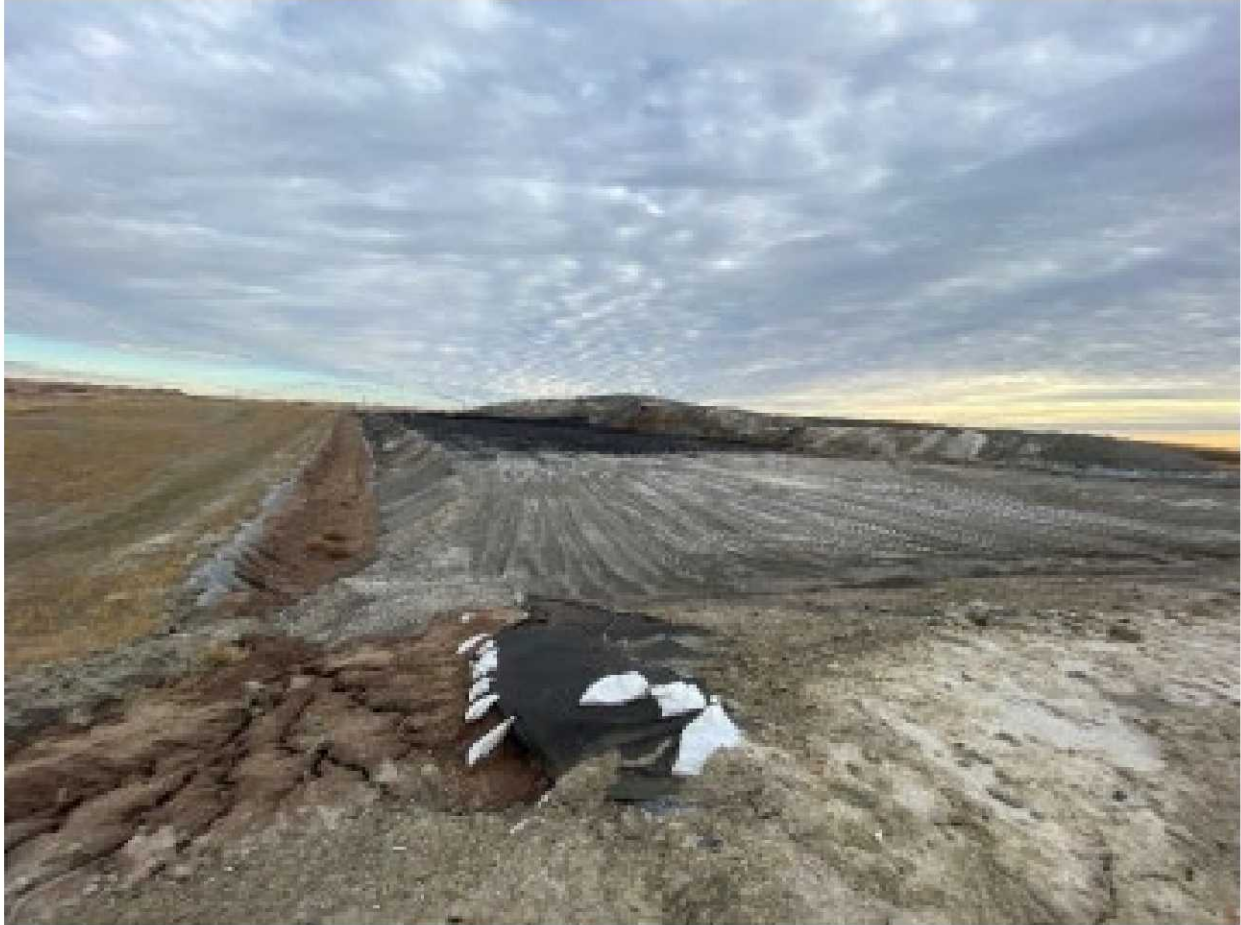
Subject: Southwest corner of active disposal area, toe of waste slope on expansion cell looking north-northeast

Comments: Suggest operations continue to maintain gap between waste and edge of liner. Fill progression appears consistent with plan.

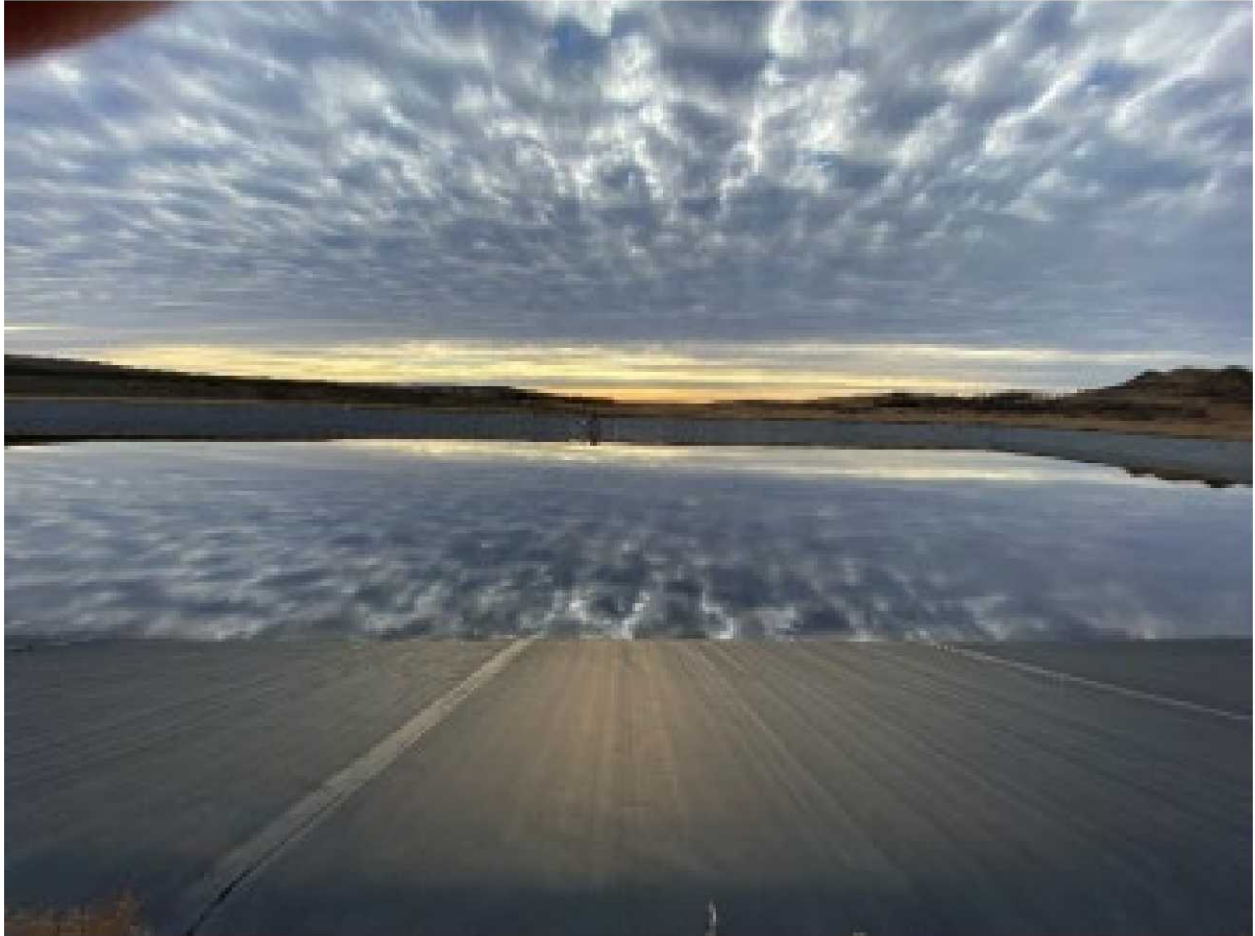
Subject: West berm of leachate pond, view to east

Comments: No damage to exposed HDPE liner; pond has adequate freeboard.
