Submitted to:
Basin Electric Power Cooperative
Laramie River Station
Wheatland, WY

Submitted by:
AECOM
Fort Collins, CO
60732883
January 17, 2025

Basin Electric Power Cooperative Laramie River Station

Coal Combustion Residual Landfill Annual Inspection Report – 2024

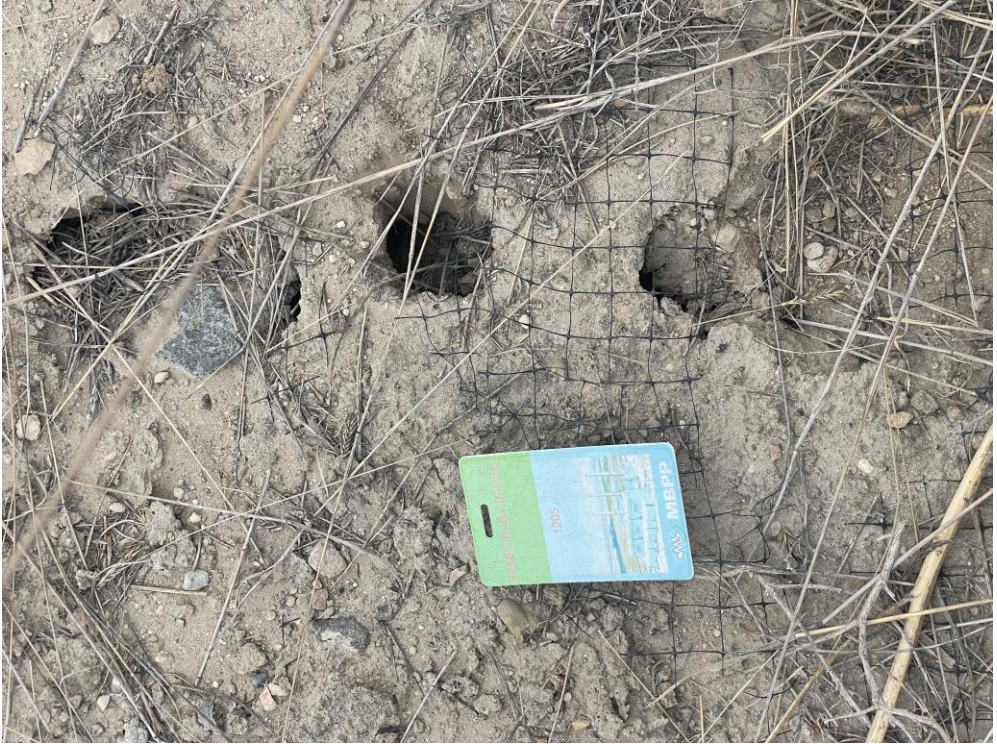
Client Name: Basin Electric Power Cooperative		Site Location: Laramie River Station, Wheatland, WY	Project No.: 60732883
Photo No. 1	Date: 12/17/24

Recommendation is to continue normal maintenance. Additionally, approximately 20-30 small animal burrows (less than 3 inches in diameter) were observed on the southern slope of Cells 1 and 2. There does not appear to be larger burrows in the area, and cover appears to be intact. While this issue appears to be controllable, it is recommended that this area be monitored and rodent control be implemented, and if the number of burrows significantly increases, repair steps may be required.

Direction Photo Taken: Birdseye view			
Description: <u>Location:</u> Southwest area of Cell 1 Example of typical shallow animal burrows observed on Cells 1 and 2.

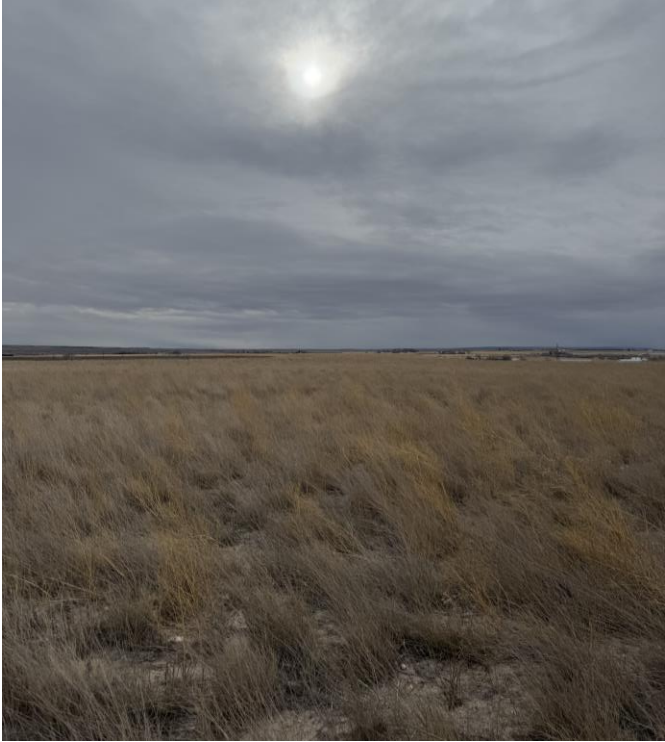
Client Name: Basin Electric Power Cooperative		Site Location: Laramie River Station, Wheatland, WY	Project No.: 60732883
Photo No. 2	Date: 12/17/24

Direction Photo Taken: East			
Description: <u>Location:</u> Cell 2 Example of good vegetation growing on top of capped area of landfill.

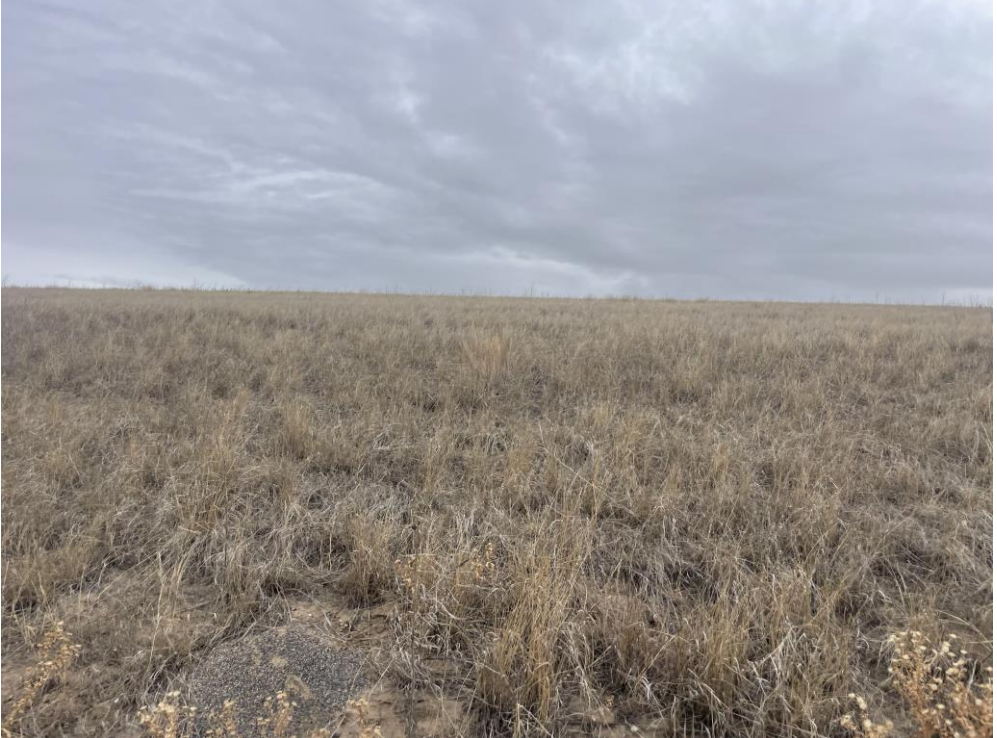
Client Name: Basin Electric Power Cooperative		Site Location: Laramie River Station, Wheatland, WY	Project No. 60732883
Photo No. 4	Date: 12/17/24

Direction Photo Taken: East			
Description: <u>Location:</u> Eastern slope of Cell 7. Good vegetation cover.

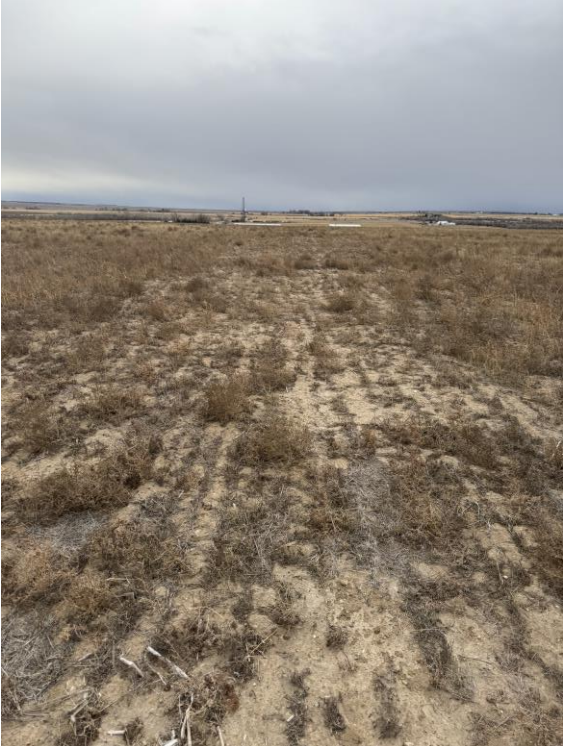
Client Name: Basin Electric Power Cooperative		Site Location: Laramie River Station, Wheatland, WY	Project No. 60732883
Photo No. 5	Date: 12/17/24

Direction Photo Taken: East			
Description: <u>Location:</u> Top of Cell 7. Thinned vegetation cover.

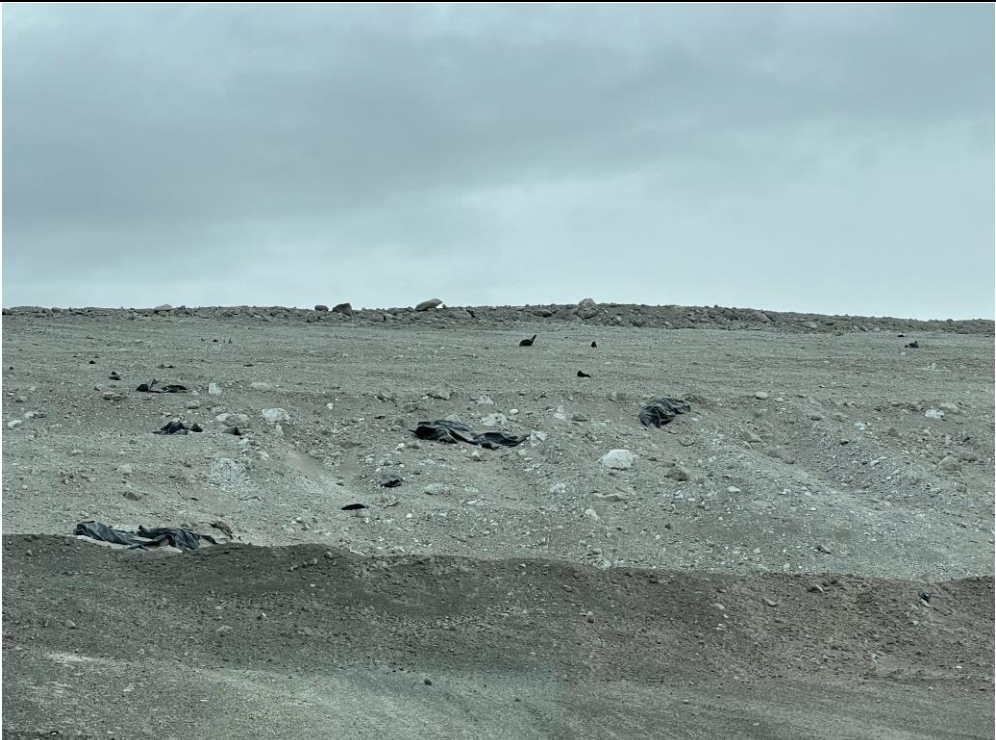
Client Name: Basin Electric Power Cooperative		Site Location: Laramie River Station, Wheatland, WY	Project No. 60732883
Photo No. 7	Date: 12/17/24

Direction Photo Taken: East			
Description: <u>Location:</u> Southern side of Cell 2. Uncapped area of Cell 2 where material from West Emergency Holding Pond is currently being placed.

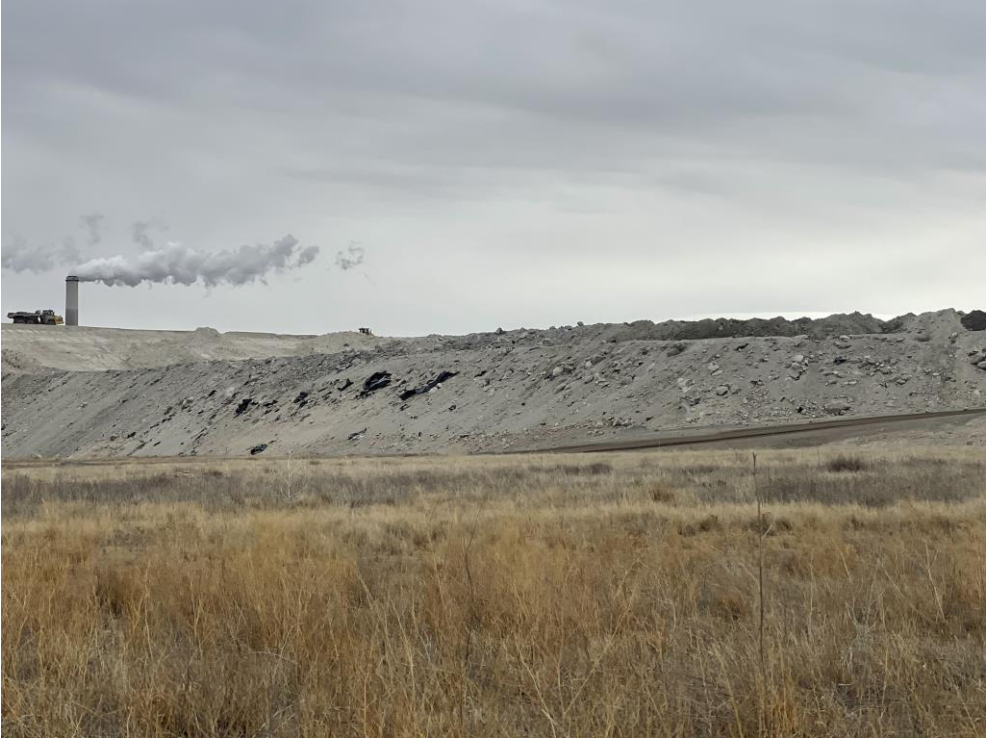
Client Name: Basin Electric Power Cooperative		Site Location: Laramie River Station, Wheatland, WY	Project No. 60732883
Photo No. 9	Date: 12/17/24

Direction Photo Taken: Southeast			
Description: <u>Location:</u> Northwest area of the landfill. Material from West Emergency Holding Pond.

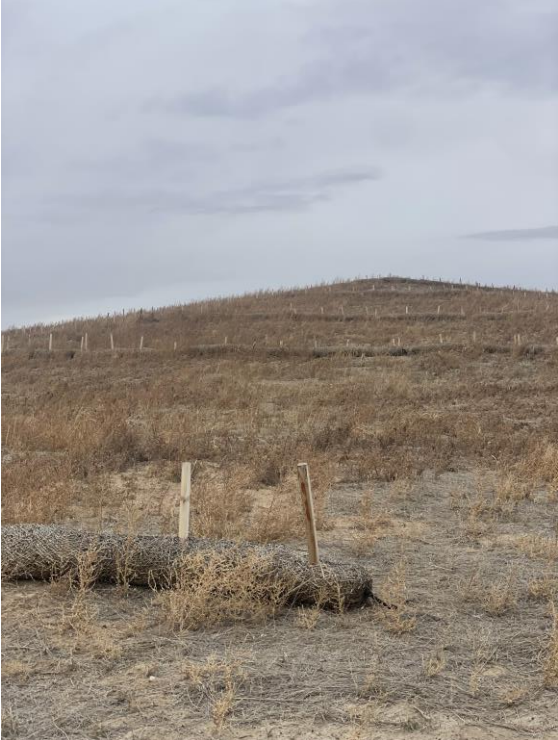
Client Name: Basin Electric Power Cooperative		Site Location: Laramie River Station, Wheatland, WY	Project No. 60732883
Photo No. 10	Date: 12/17/24

Direction Photo Taken: Northwest			
Description: <u>Location:</u> Southeast corner of Cell 1. Sediment controls in place.
