Submitted to:
Basin Electric Power Cooperative
Laramie River Station
Wheatland, WY

Basin Electric Power Cooperative Laramie River Station

Coal Combustion Residual Surface Impoundment Annual Inspection Report – 2023

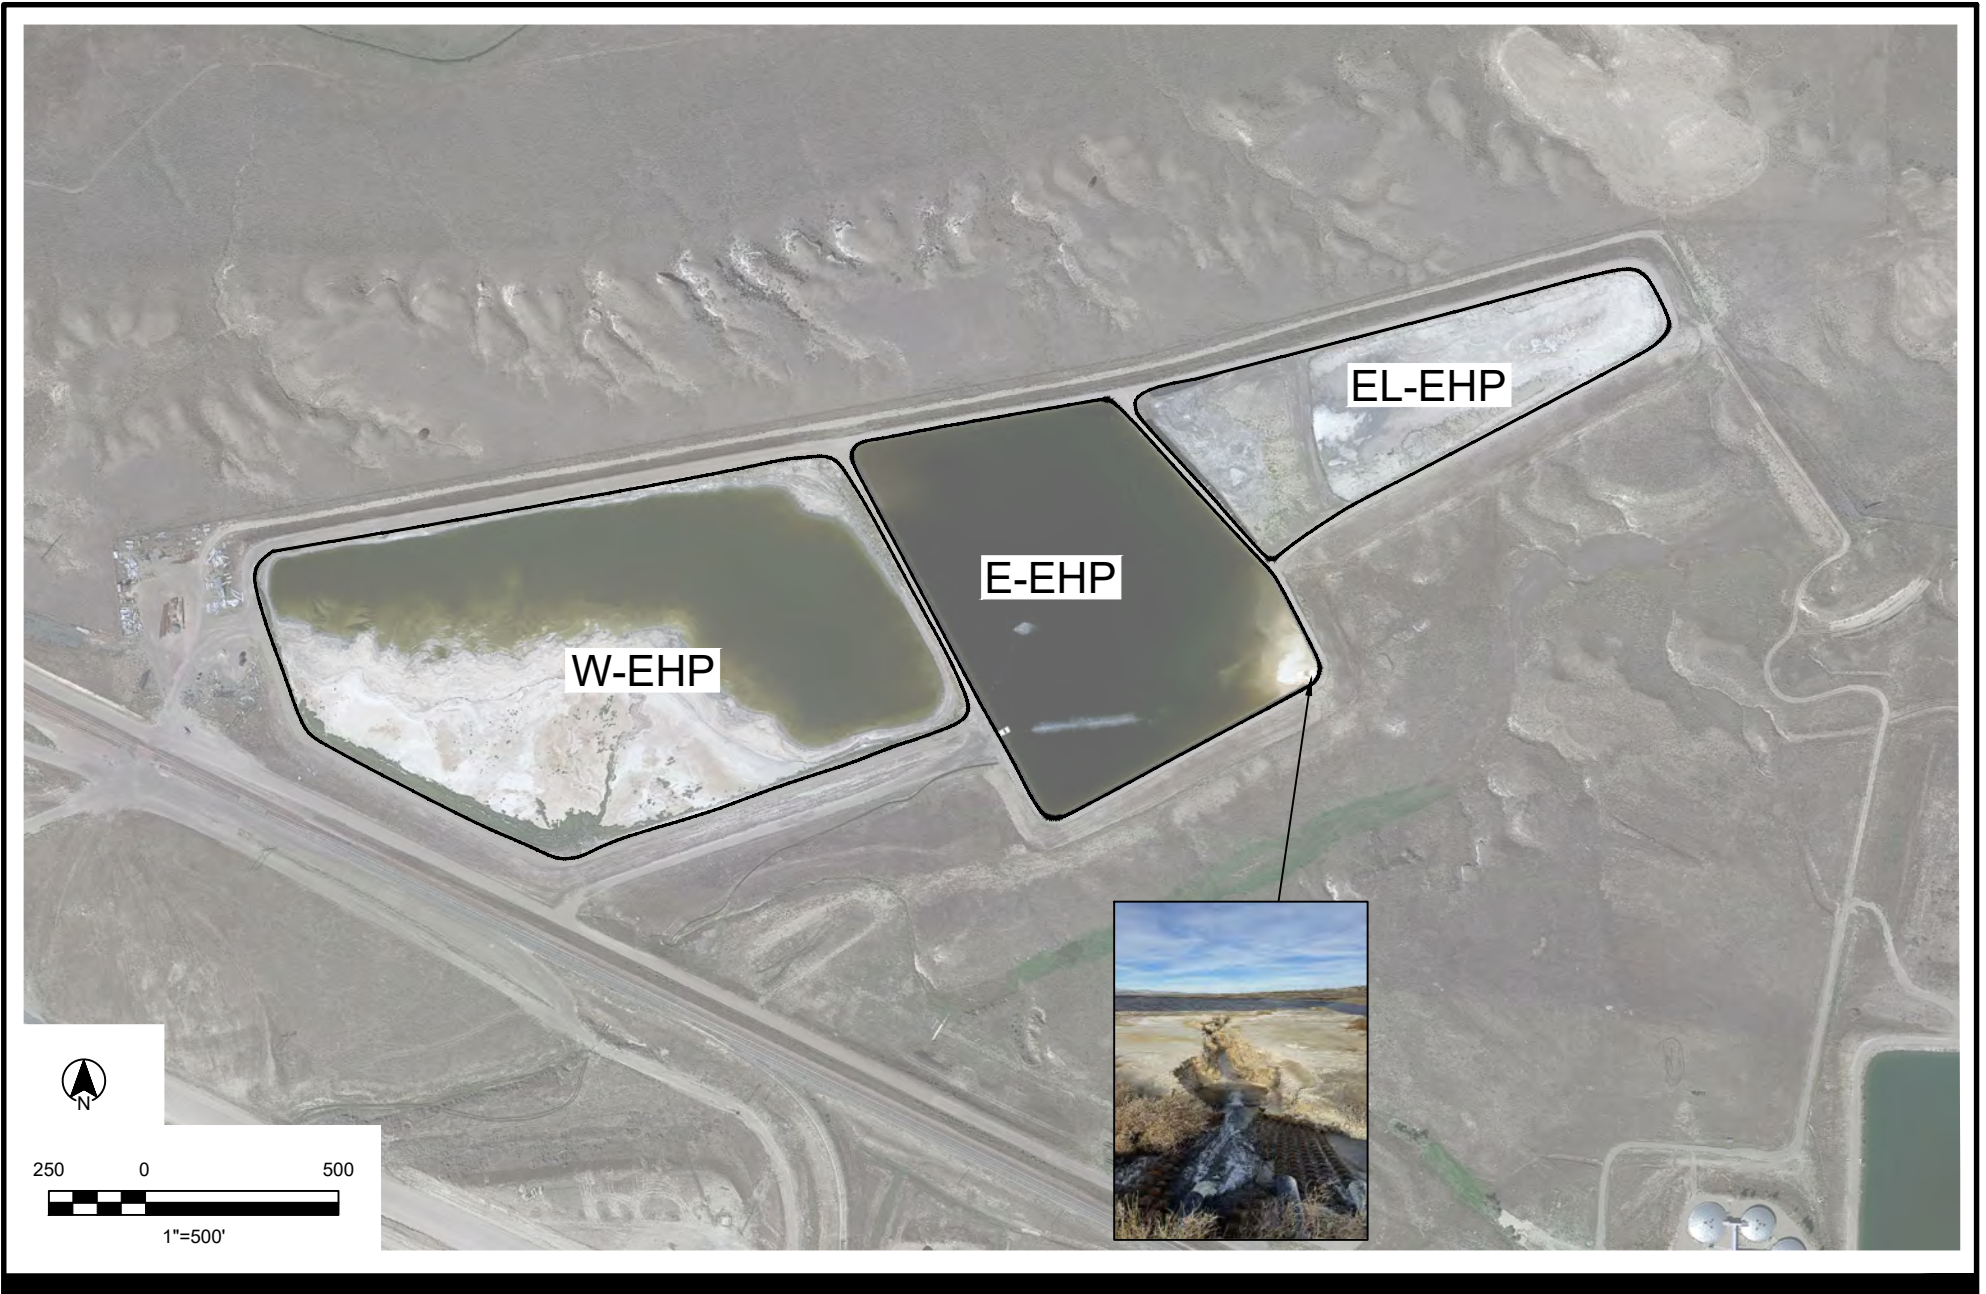
Client Name: Basin Electric Power Cooperative		Site Location: Laramie River Station, Wheatland, WY	Project No. 60632474
Photo No. 1	Date: 12/6/23	 	
Direction Photo Taken: Northwest			
Description: <u>Location:</u> southeast corner of E-EHP The inlet of the E-EHP is pictured.
