Emergency Action Plan

Laramie River Station
347 Grayrocks Road
Wheatland, Wyoming
Owned by Missouri Basin Power Project
Operated by Basin Electric Power Cooperative
Wheatland, Wyoming

AECOM Project Number: 60429243 April 17, 2017

CCR Units: Basin Electric Power Cooperative; Laramie River Station; Bottom Ash Ponds 1, 2, & 3; East and West Emergency Holding Ponds

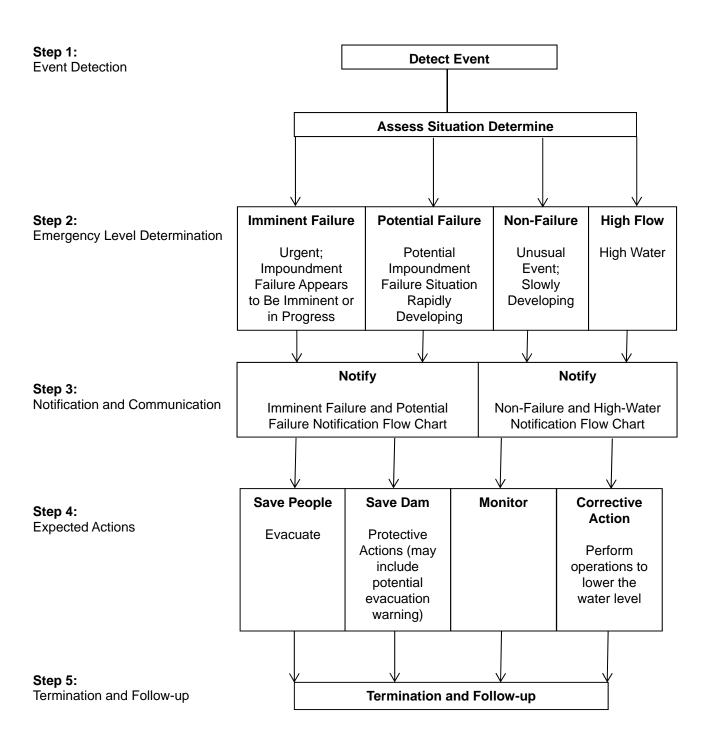
Level of Emergency Determination Chart

Event	Situation	Emergency Level*
Embankment Overtopping	Reservoir level is 1 foot below the top of the impoundment	Potential Failure
	Water from the reservoir is flowing over the top of the impoundment	Imminent Failure
Seepage	New seepage areas in or near the impoundment	Non-failure
	New seepage areas with cloudy discharge or increasing flow rate	Potential Failure
Sinkholes	Observation of new sinkhole in reservoir area or on embankment	Potential Failure
	Rapidly enlarging sinkhole	Imminent Failure
Embankment / Structural	New cracks in the embankment/structural component greater than ¼-inch wide without seepage	Non-failure
Component Cracking	Cracks in the embankment/structural component with seepage	Potential Failure
Embankment	Visual movement/slippage of the embankment slope/structural component	Non-failure
/ Structural Component Movement	Sudden or rapidly proceeding slides of the embankment slopes/structural component	Imminent Failure

Security Threat	Verified bomb threat that, if carried out, could result in damage to the impoundment	Potential Failure
	Detonated bomb that has resulted in damage to the impoundment or appurtenances	Imminent Failure
Sabotage/	Unauthorized operation of the impoundment	Non-failure
Vandalism	Damage that could adversely impact the functioning of the impoundment or appurtenances	Non-failure
	Modification to the impoundment or appurtenances that could adversely impact the functioning of the impoundment	Potential Failure
	Damage to impoundment or appurtenances that has resulted in seepage flow	Potential Failure
	Damage to impoundment or appurtenances that has resulted in uncontrolled water release	Imminent Failure
